Connecticut Coastal Structures Inventory Study

SECTION 22
CONNECTICUT COASTAL STRUCTURES INVENTORY STUDY

PHASE I - NEW LONDON COUNTY

APPENDIX D
ATLANTIC QUADRANGLE
RECORDS OF STRUCTURES WITH PHOTOGRAPHS

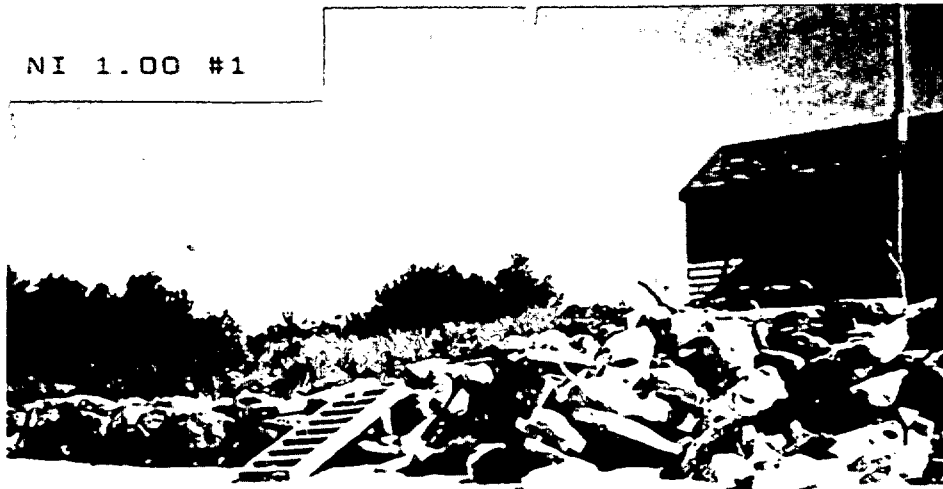
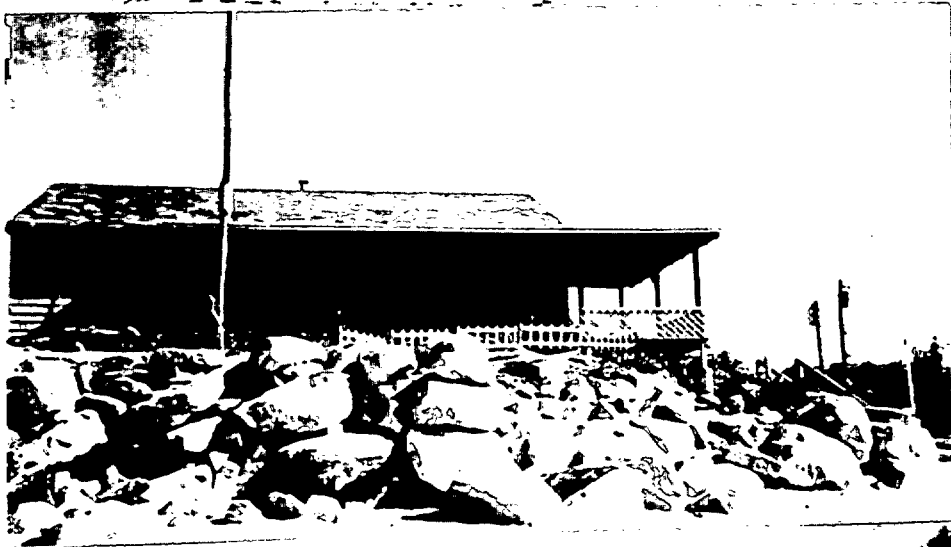
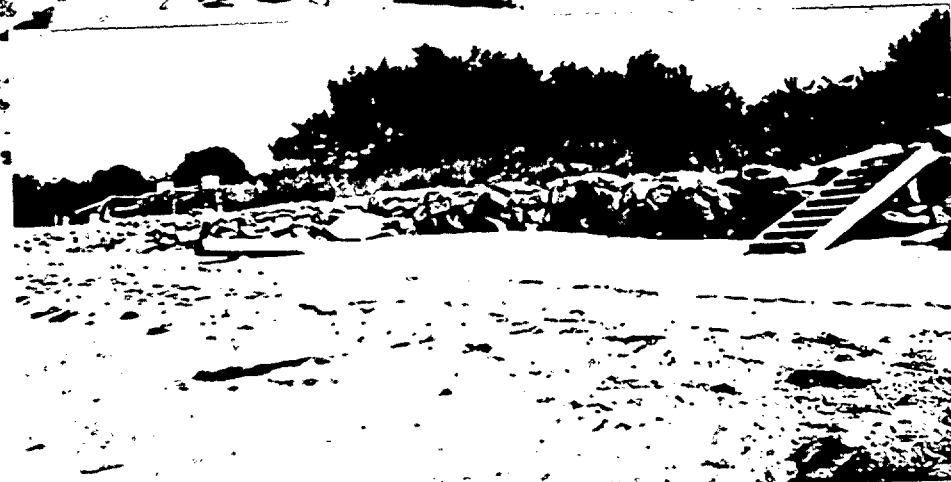
NI 1.00 #1

TYPE OF STRUCTURE: BULKHEAD CONDITION: GOOD
MAIN FUNCTION : STORM PROTECTION AND PROPERTY RETENTION
MATERIAL : BOULDERS

APROX L= 500 FT, W= 3 FT AT UPRIGHT SECTION
W= 6 FT AT SLOPING SECTION, H= 5-10 FT ABOVE MHW. REVETMENT
ON BOTH SIDES BUT MORE LIKE A BULKHEAD IN CENTER.

#1 ROLL 18 NEG 19-21 PANORAMIC VIEW OF STRUCTURE FROM WATER'S
#2 EDGE AT EAST END OF STRUCTURE
#3
#4
#5

SHORE IS ALL SANDY BEACH. STRUCTURE COULD BE BROKEN INTO 2
REKETMENTS AND A BULKHEAD, BUT SINCE IT APPEARS TO HAVE BEEN
BUILT AS A UNIT WE CLASSIFIED IT AS ONE STRUCTURE.

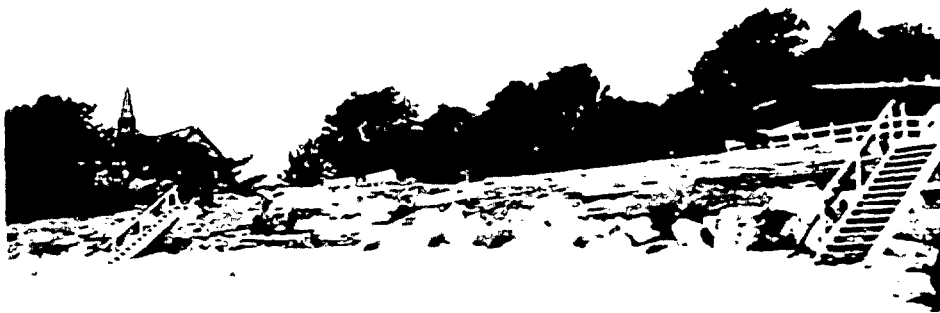
NI 3.00 #1

TYPE OF STRUCTURE: BULKHEAD CONDITION: POOR
MAIN FUNCTION : RETAINS PROPERTY. DOES NOT PROTECT AGAINST WAVE ER
MATERIAL : WOOD PLANKS

SHORE: SANDY BEACH
SOME PLANKS ROTTED, PLANKS MISSING IN MANY SPOTS (25% GONE)

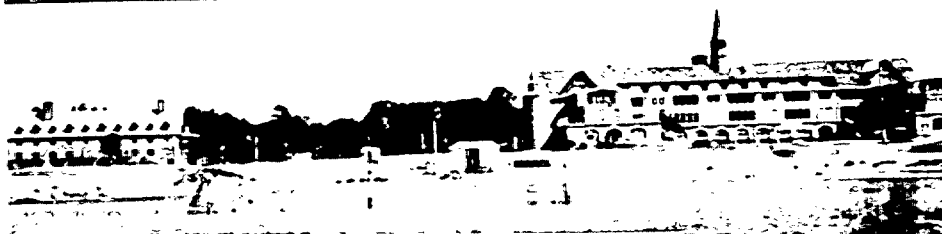
NI 4.00 #1

TYPE OF STRUCTURE: SEAWALL CONDITION: GOOD
MAIN FUNCTION : RETAINS LAND AND PROVIDES STORM PROTECTION
MATERIAL : STONE IN CEMENT

STATE OF CONN. SEASIDE CENTER FOR THE MENTALLY RETARDED.
SHORE: POCKETS OF SANDY SHORE IN FRONT OF SEAWALL BETWEEN
GROINS.

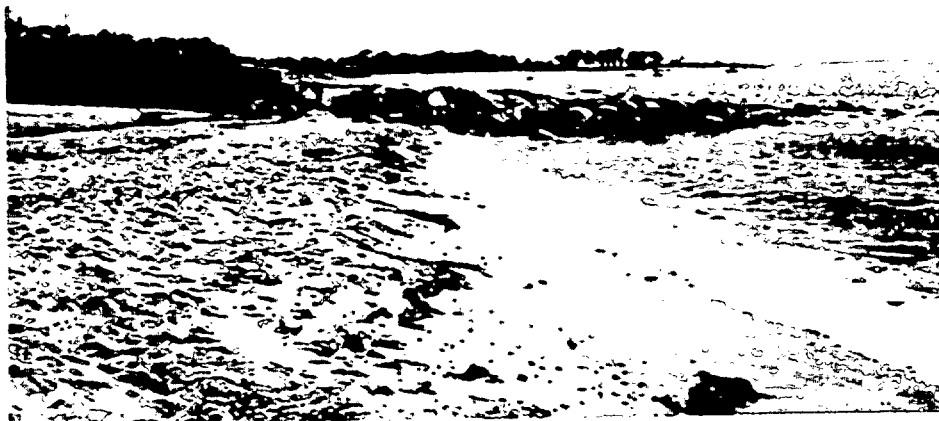
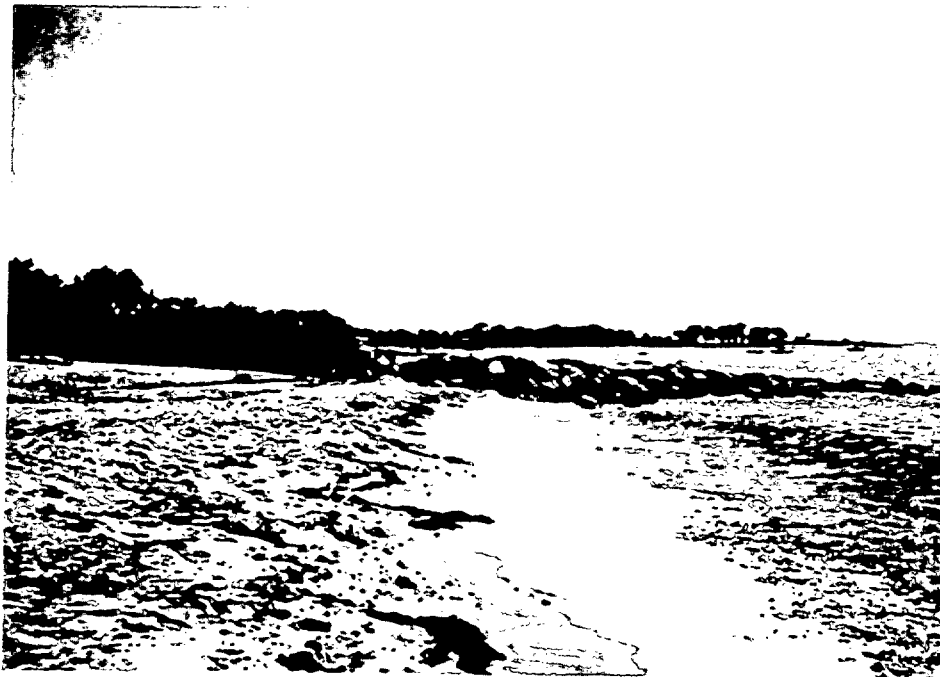
NI 5.00 #1

TYPE OF STRUCTURE: GROIN
MAIN FUNCTION : RETAINS BEACH IN FRONT OF STRUCTURE 4
MATERIAL : STONE
CONDITION: FAIR

STATE OF CONNECTICUT SEASIDE CENTER FOR THE MENTALLY
RETARDED. SHORE: SANDY BEACH IN FRONT OF SEAWALL BETWEEN
MANY GROINS.

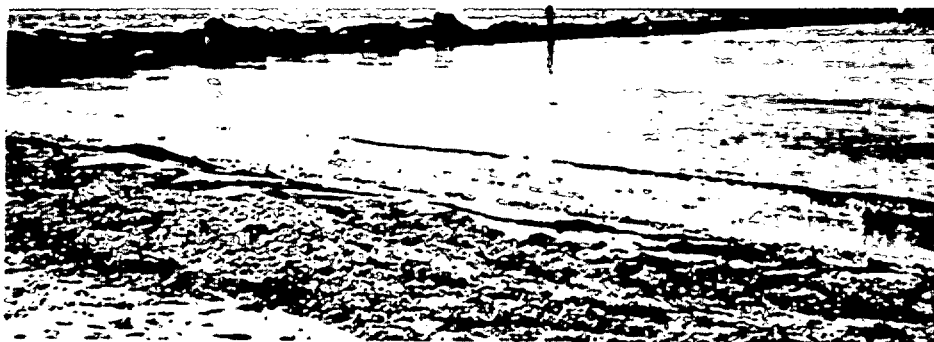
NI 6.00 #1

TYPE OF STRUCTURE: GROIN CONDITION: GOOD
MAIN FUNCTION : RETAINS BEACH TO WEST AND SHELTERS SWIMMING AREA
MATERIAL : STONE

STATE OF CONNECTICUT SEASIDE CENTER FOR THE MENTALLY
RETARDED. SHORE: SANDY POCKETS OF BEACH IN FRONT OF SEAWALL
BETWEEN GROINS.

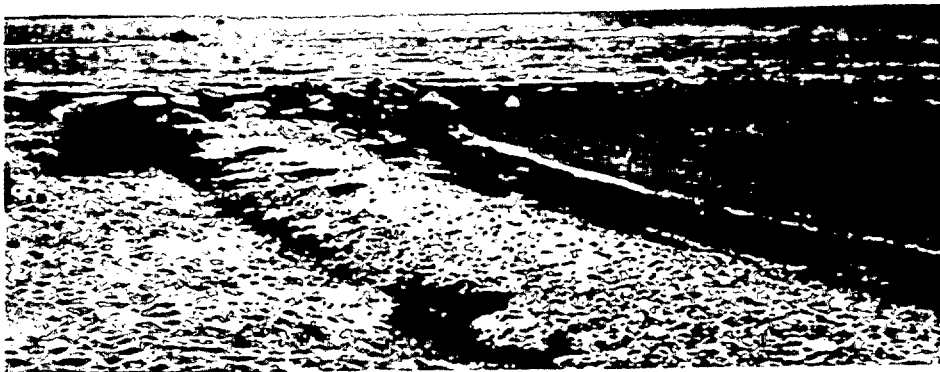
NI 3.00 #1

TYPE OF STRUCTURE: GROIN CONDITION: GOOD
MAIN FUNCTION : RETAINS BEACH IN FRONT OF STRUCTURE 4
MATERIAL : STONE

STATE OF CONN. SEASIDE CENTER FOR THE MENTALLY RETARDED.
SHORE: POCKETS OF SANDY BEACH IN FRONT OF STRUCTURE 4
BETWEEN GROINS.

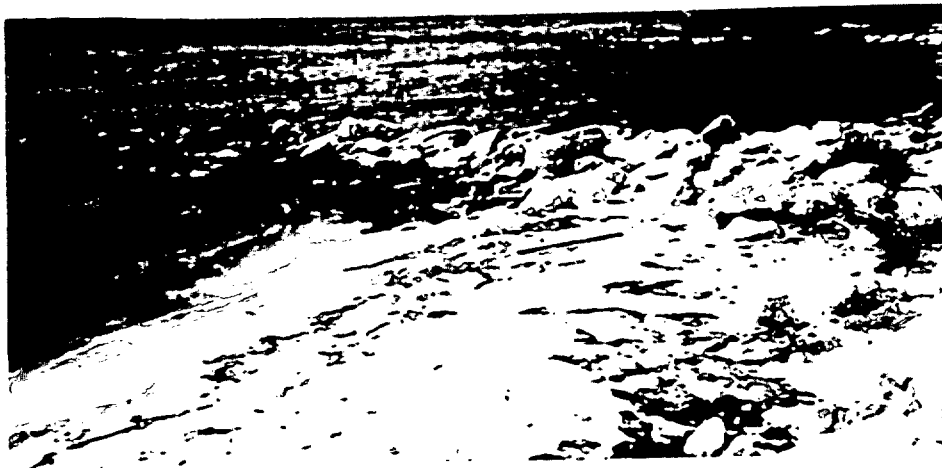
NI 0.00 #1

TYPE OF STRUCTURE: GROIN CONDITION: FAIR
MAIN FUNCTION : RETAINS BEACH IN FRONT OF SEAWALL (STRUCTURE 4)
MATERIAL : STONE

STATE OF CONN. SEASIDE CENTER FOR THE MENTALLY RETARDED.
SHORE: POCKETS OF SANDY OR PEBBLY BEACH IN FRONT OF SEAWALL
BETWEEN GROINS.

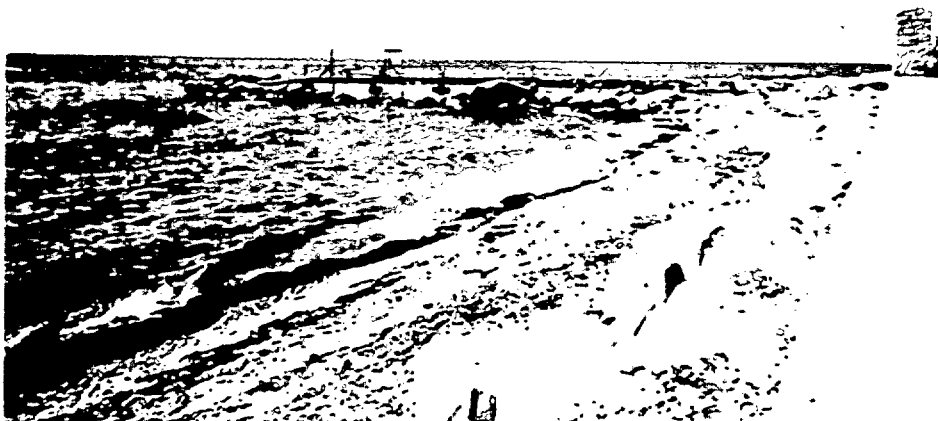
NI 10.00 41

TYPE OF STRUCTURE: GROIN CONDITION: FAIR
MAIN FUNCTION : RETAINS BEACH IN FRONT OF SEAWALL (STRUCTURE 4)
MATERIAL : STONE

STATE OF CONN. SEASIDE CENTER FOR THE MENTALLY RETARDED.
SHORE: PEBBLY BEACH. GROIN MAKES BOUNDARY BETWEEN SEASIDE
CENTER AND PRIVATE HOME TO WEST.

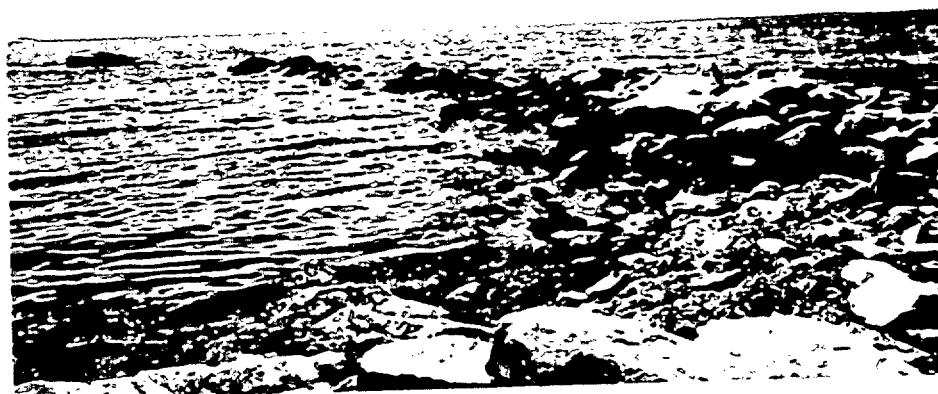
11.00 11

TYPE OF STRUCTURE: GROIN CONDITION: POOR
MAIN FUNCTION : PROTECTION OF BEACH AREA AT POINT
MATERIAL : STONE

SHORE: COMPOSED OF EXPOSED BEDROCK WITH SOME SAND, SMALL
STONES, PEBBLES, AND CRUSHED SEASHELLS DISPERSED ON THE
EXPOSED BEDROCK.

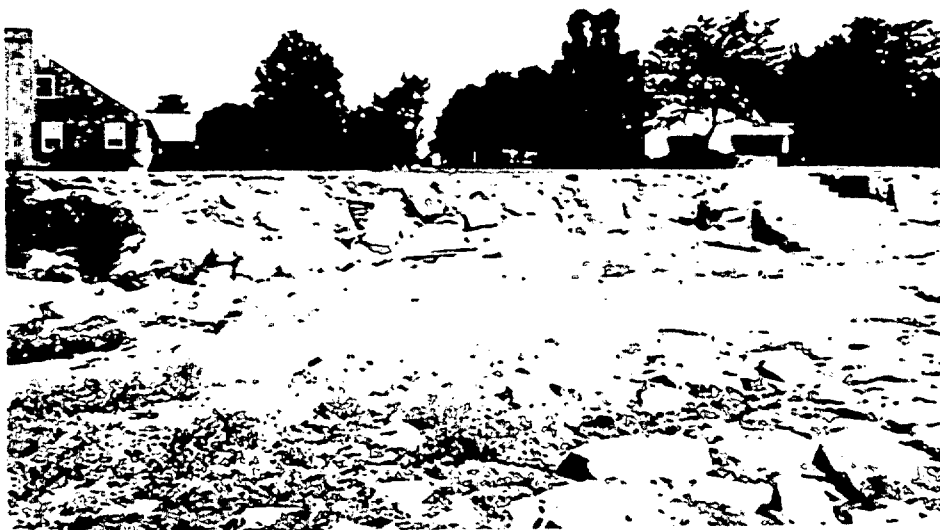
NI 12.00 #1

TYPE OF STRUCTURE: SEAWALL CONDITION: GOOD
MAIN FUNCTION : RETAINS LAND, PROVIDES STORM BUT NOT EROSION PROTE
MATERIAL : STONE IN CEMENT

SHORE: TIP OF POINT IS EXPOSED BEDROCK.

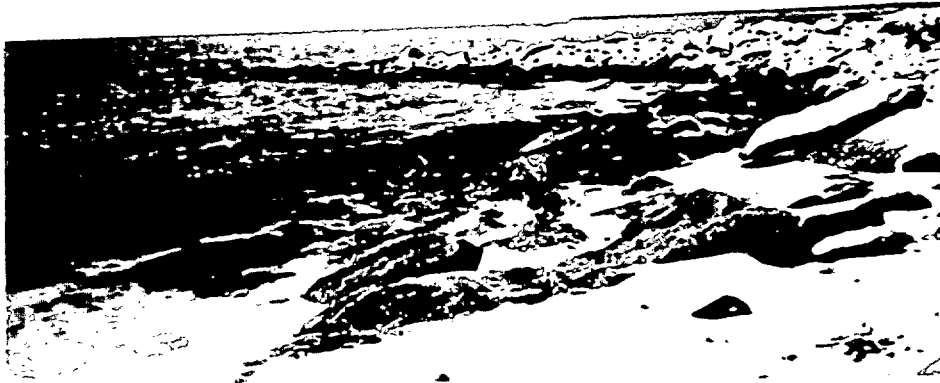
NI 13.00 #1

TYPE OF STRUCTURE: GROIN CONDITION: POOR
MAIN FUNCTION : RETAINS BEACH BETWEEN ITSELF AND SEASIDE POINT
MATERIAL : STONE

END OF GROIN FALLING APART. SANDY BEACH WITH LARGE BOULDERS
TO EAST. ROCKY SHORE TO WEST, NO PROTECTION NECESSARY.
STRUCTURE IS MORE LIKE A RIPRAPPED SHORE ON WEST SIDE.

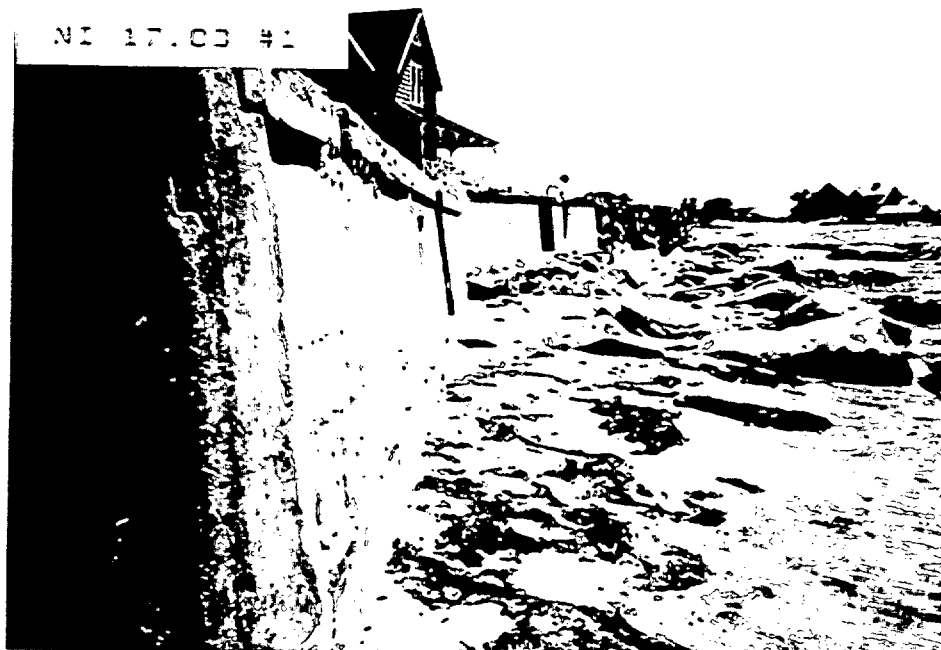
TYPE OF STRUCTURE: SEAWALL CONDITION: GOOD
MAIN FUNCTION : SUPPORT OF LAND AND PROTECTION FROM WAVE ACTION
MATERIAL : CONCRETE

RESIDENT NOTED AREA WAS REPORTEDLY SANDY BEACH 40 FT WIDE
BEFORE BREAKWATERS AT WHITE POINT WERE BUILT. LAST STORM
FROM WEST DAMAGE WAS DONE TO SEAWALL # 18.

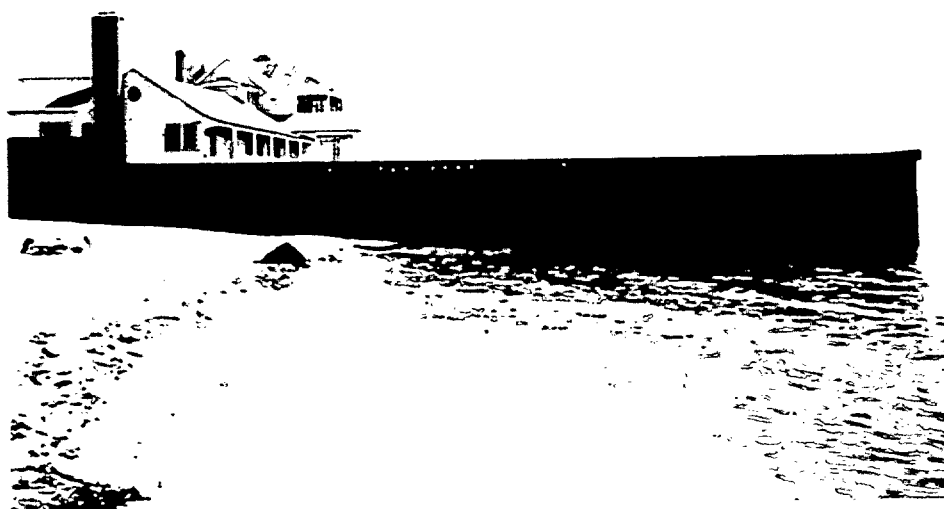
NI 23.00 #1

TYPE OF STRUCTURE: BULKHEAD CONDITION: POOR
MAIN FUNCTION : SUPPORT OF LAND AND PROTECTION FROM WAVE ACTION
MATERIAL : STEEL

LOWER PORTIONS OF BULKHEAD ARE IN CONSTANT CONTACT WITH
WATER CAUSING MANY HOLES. LAST WINTER STORM TOPPED SOUTH
SIDE AND WASHED OUT PORTION OF YARD BEHIND HOUSE.

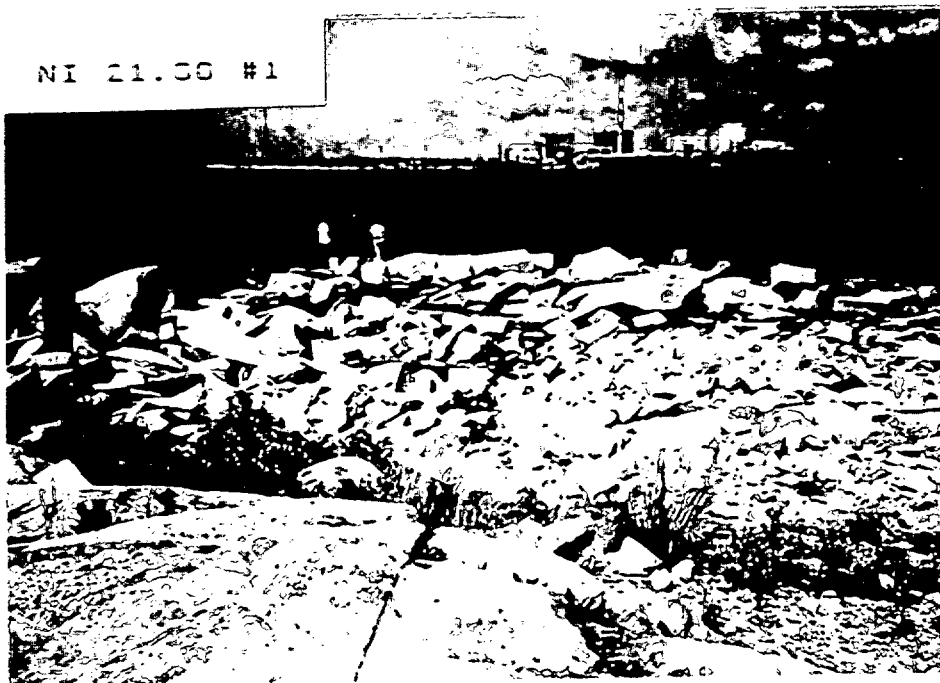
NI 21.00 #1

TYPE OF STRUCTURE: RIPRAP CONDITION: FAIR
MAIN FUNCTION : FISHING AREA. ALSO PROTECTS BOAT RAMP TO NORTH FR
MATERIAL : STONE

SHORE: TO NORTH LINED WITH PROTECTIVE STRUCTURES. TO EAST,
EXPOSED BEDROCK POINT (PLEASURE BEACH BEYOND POINT).

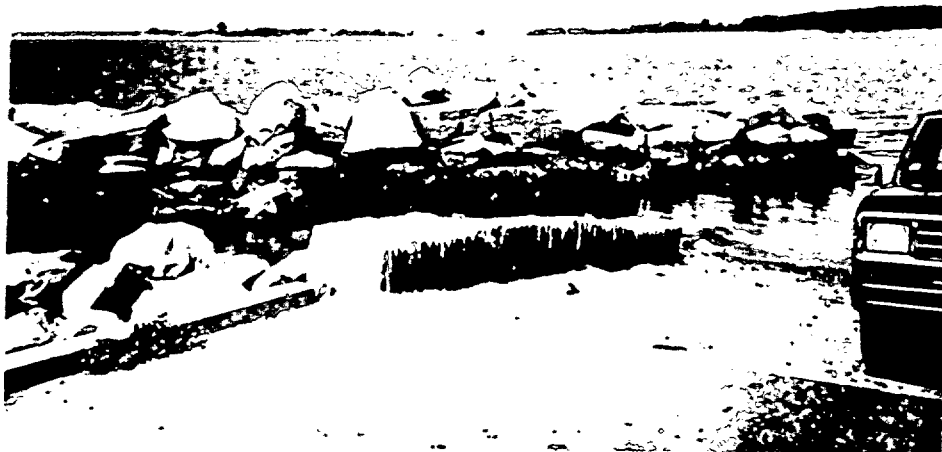
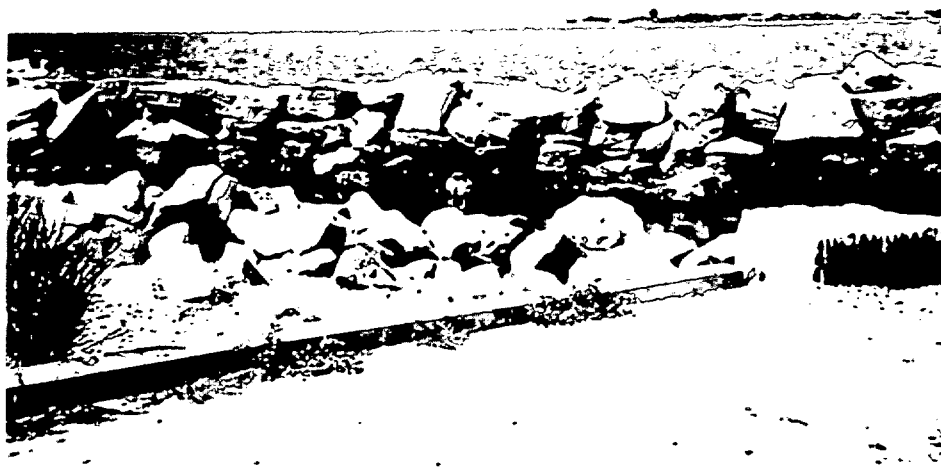
NI 22.00 #1

TYPE OF STRUCTURE: BREAKWATER CONDITION: GOOD
MAIN FUNCTION : PROTECTS BOAT RAMP TO IMMEDIATE NORTH FROM WAVES
MATERIAL : LARGE BOULDERS

SHORE: LINED WITH PROTECTIVE STRUCTURES ON BOTH SIDES

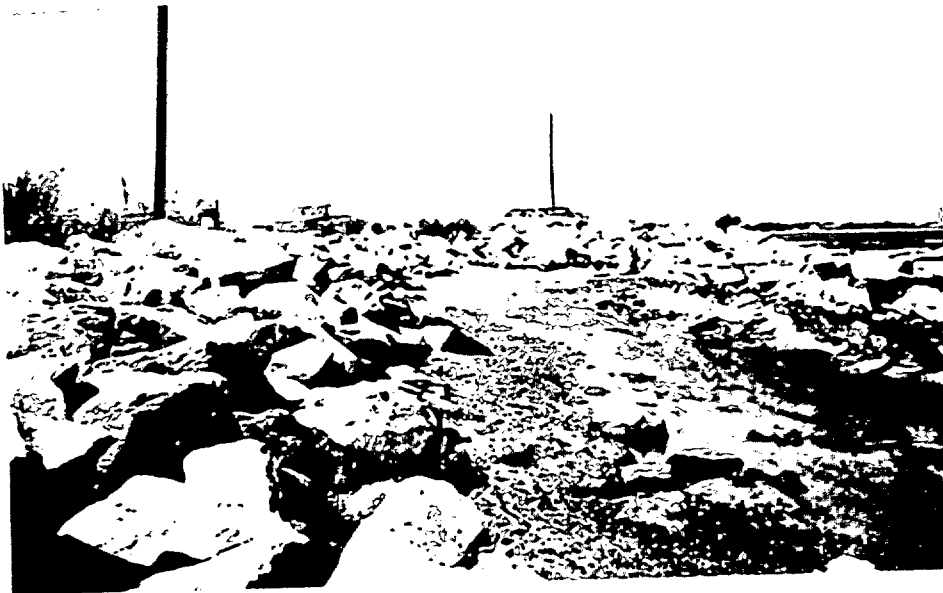
NI 23.00 #1

TYPE OF STRUCTURE: REVETMENT CONDITION: GOOD
MAIN FUNCTION : S. HALF HALTS WAVE EROSION, N. HALF HALTS STREAM E
MATERIAL : BOULDERS/STONE

SHORE LINED WITH PROTECTIVE STRUCTURES

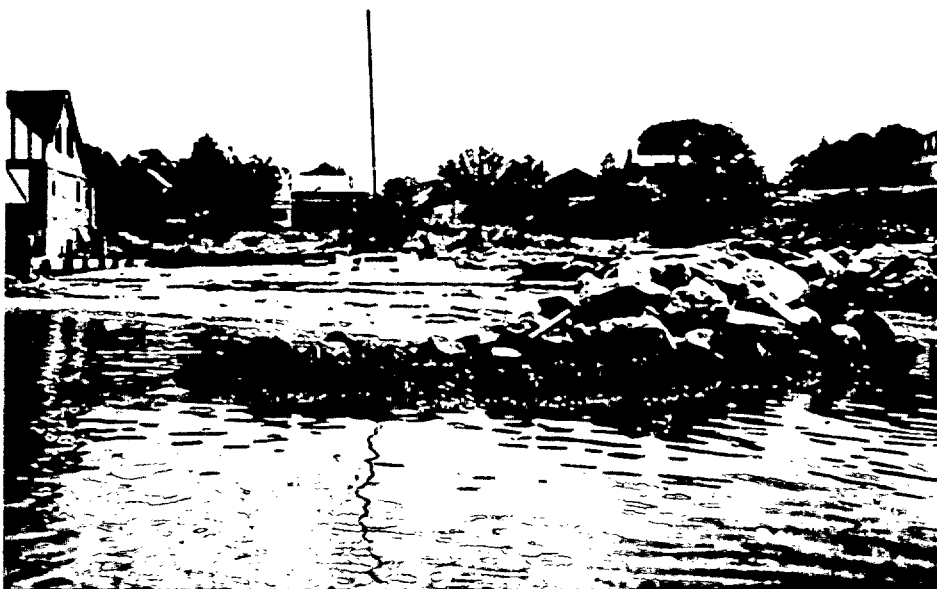
NI 24.00 #1

TYPE OF STRUCTURE: GROIN CONDITION: POOR
MAIN FUNCTION : MAINTAINS SMALL PRIVATE BEACH
MATERIAL : STONE

SHORE LINED WITH PROTECTIVE STRUCTURES. PERMIT IS FOR THE
IMPROVEMENT OF THE GROIN.

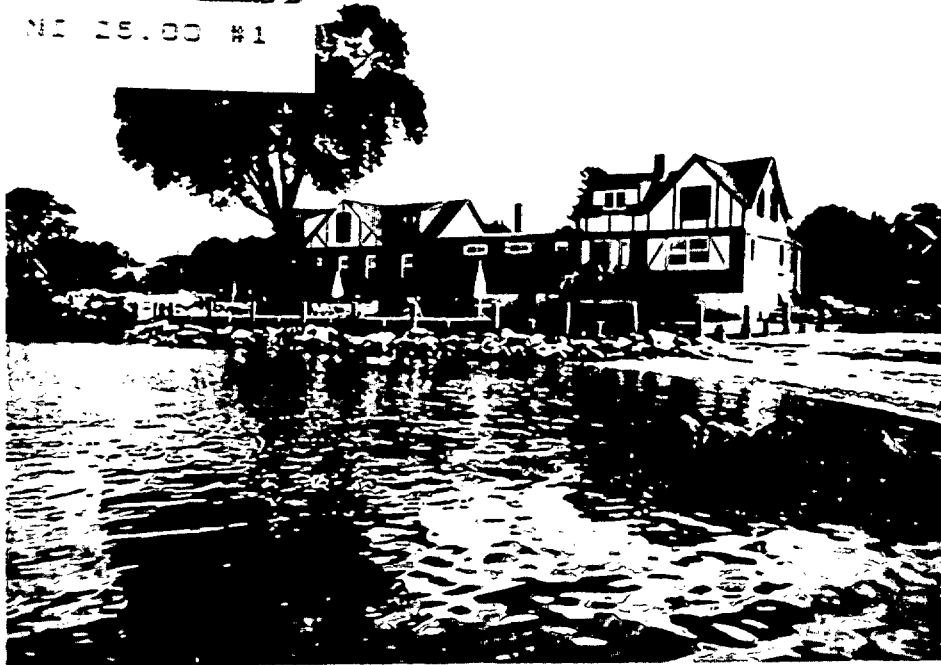
NE 25.00 #1

TYPE OF STRUCTURE: BULKHEAD/RIPRAP CONDITION: GOOD
MAIN FUNCTION : TO RETAIN PRIVATE LOT
MATERIAL : WOOD & STONE

SHORE LINED WITH PROTECTIVE STRUCTURES. WOOD BULKHEAD WITH
RIPRAP APRON.

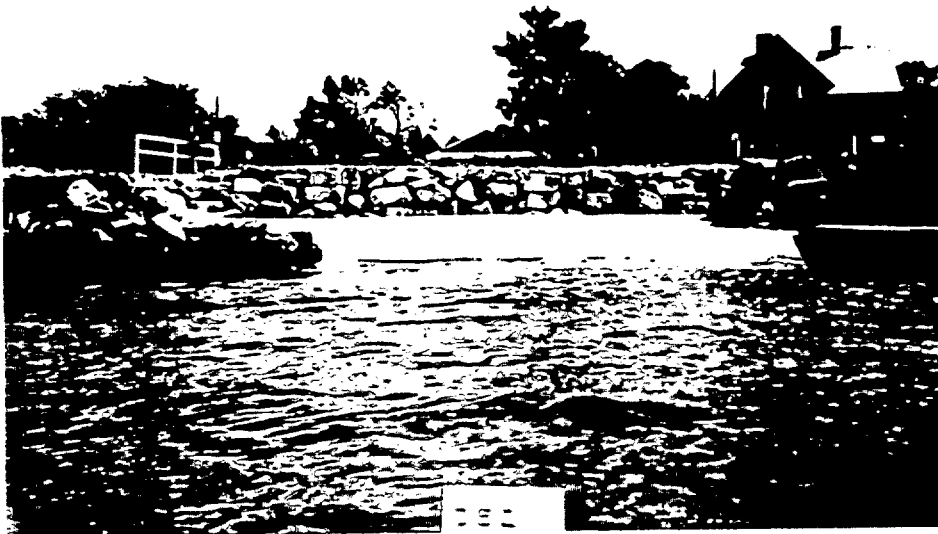
NI 26.00 #1

TYPE OF STRUCTURE: BULKHEAD CONDITION: GOOD
MAIN FUNCTION : RETAINS PROPERTY/SMALL BEACH. PREVENTS EROSION.
MATERIAL : STONES

SHORE LINED WITH PROTECTIVE STRUCTURES

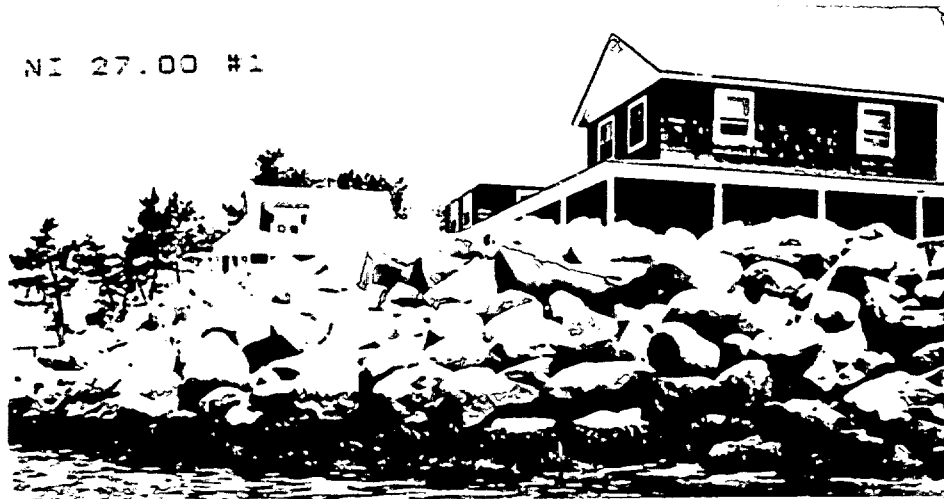
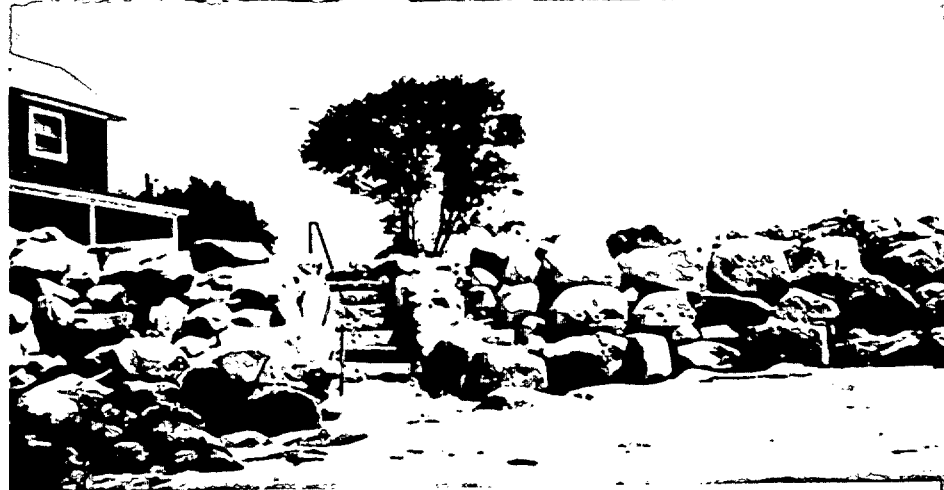
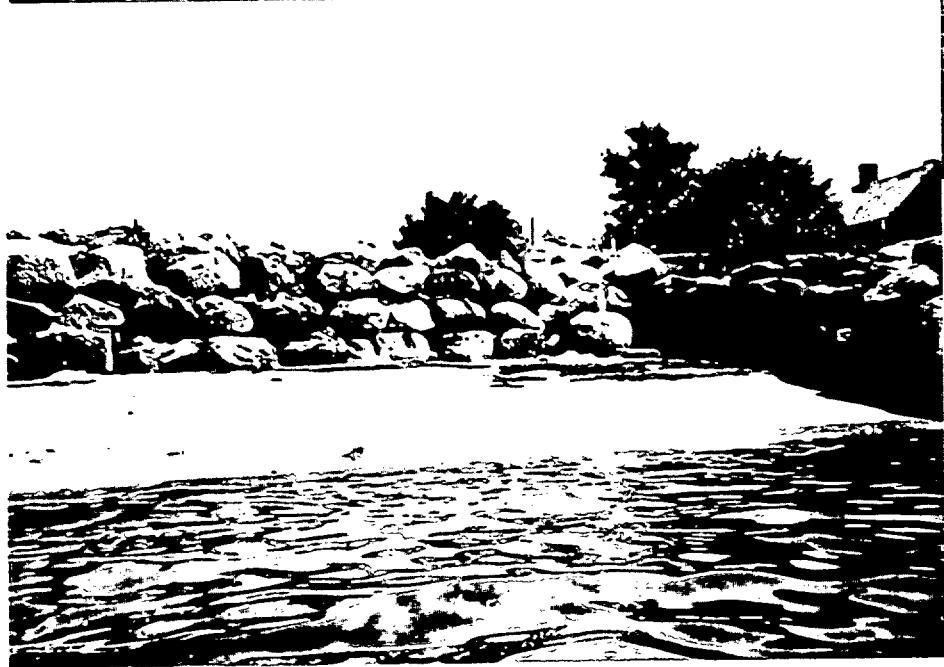
NI 27.00 #1

TYPE OF STRUCTURE: BULKHEAD
MAIN FUNCTION : MAINTAIN PRIVATE LOT IN FRONT OF TWO SMALL HOUSES
MATERIAL : LARGE STONES
CONDITION: GOOD

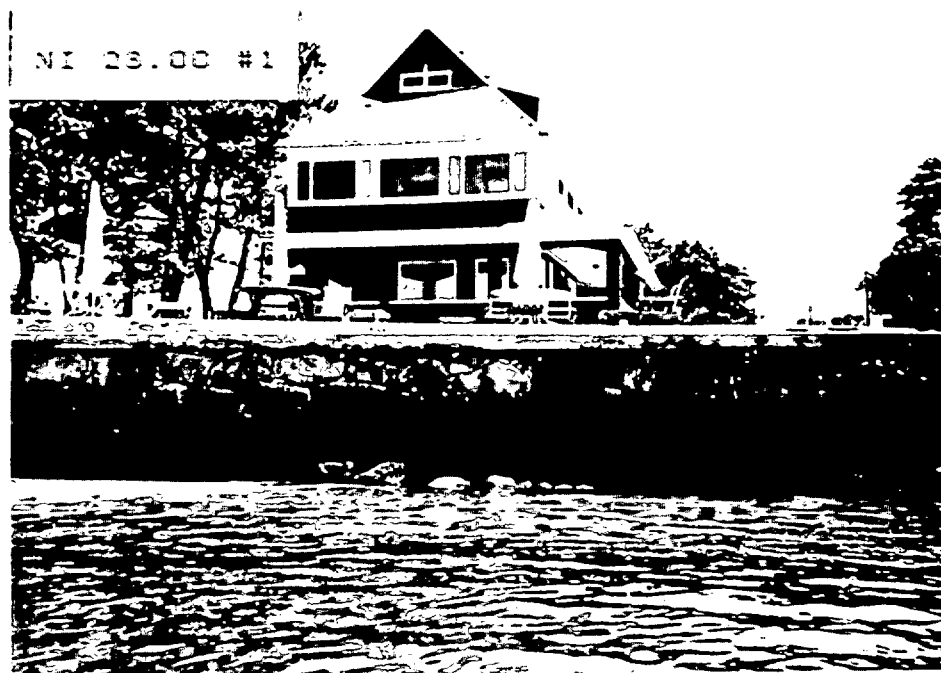
TYPE OF STRUCTURE: BULKHEAD CONDITION: FAIR
MAIN FUNCTION : RETAINS PROPERTY
MATERIAL : STONE IN CEMENT

SHORE LINED WITH PROTECTIVE STRUCTURES. STRUCTURE HAS
SEVERAL HOLES. CEMENT FALLING OUT IN SOME SPOTS.

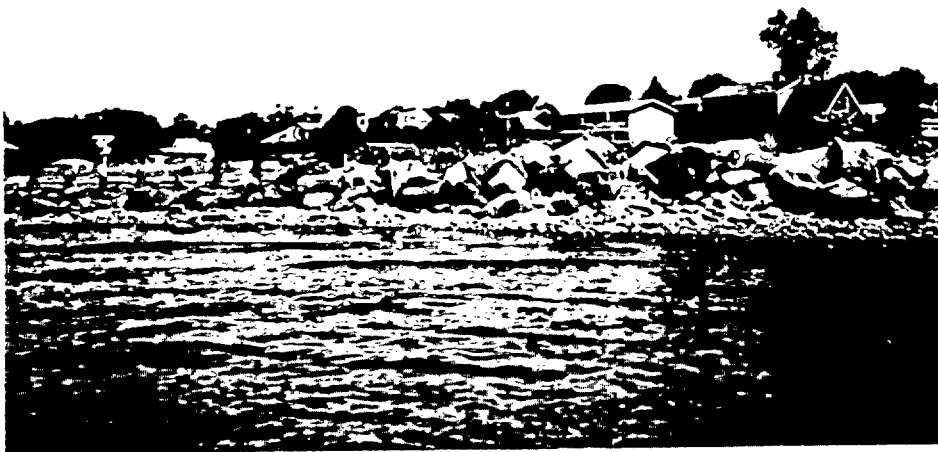
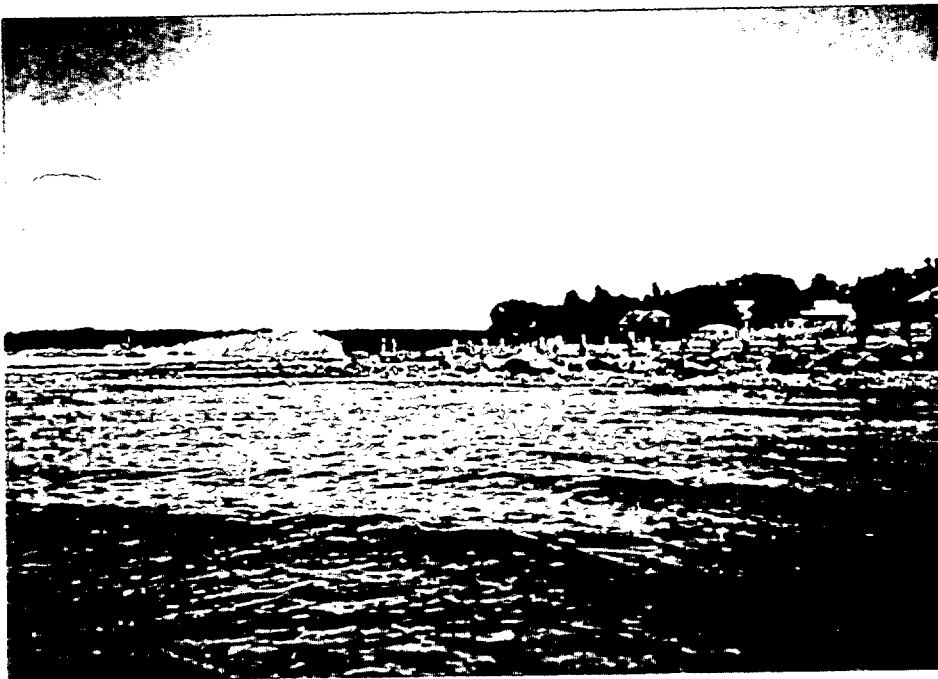
NI 33.00 #1

TYPE OF STRUCTURE: BULKHEAD/RIPRAP CONDITION: POOR
MAIN FUNCTION : PROTECTS FILL AREA FROM EROSION IN AREA ACROSS COV
MATERIAL : WOOD AND STONE

BULKHEAD HAS RIPRAP

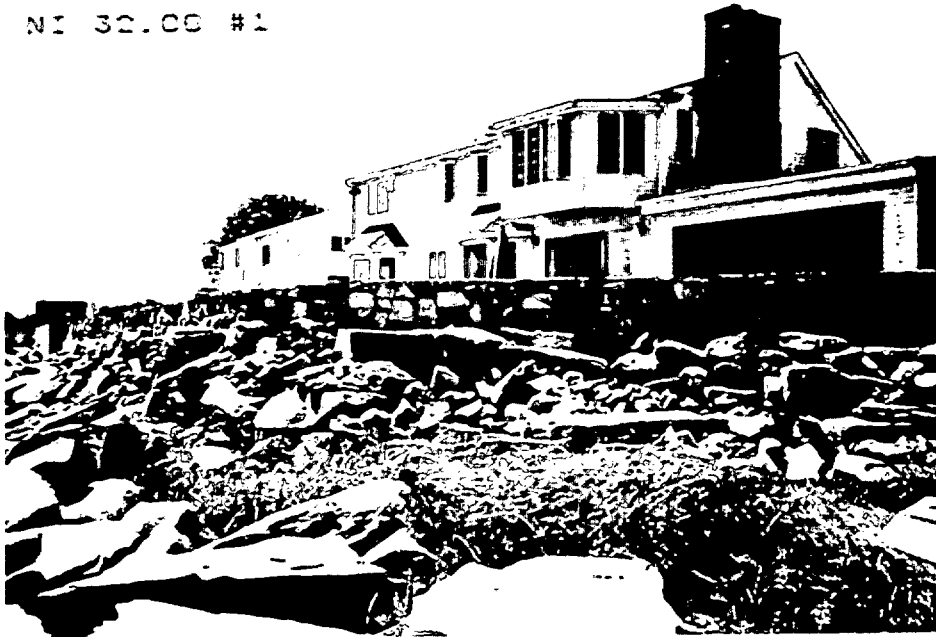
N1 32.00 #1

TYPE OF STRUCTURE: SEAWALL&RIPRAP CONDITION: GOOD
MAIN FUNCTION : RETAINS LAND AND PREVENTS EROSION
MATERIAL : STONE IN CEMENT

SHORE IS SANDY TO NORTH AND SOUTHWEST

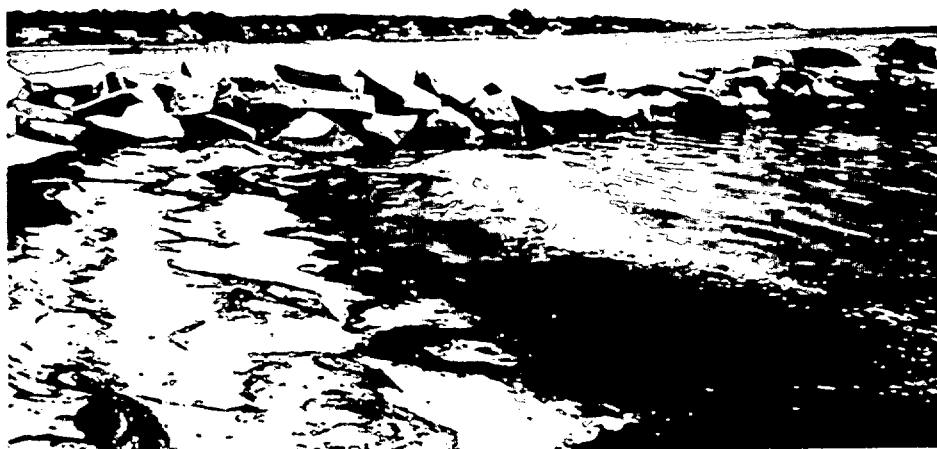
NI 10.00 31

TYPE OF STRUCTURE: GROIN CONDITION: GOOD
MAIN FUNCTION : RETAINS SANDY BEACH TO WEST
MATERIAL : STONE

SHORE IS LINED WITH STRUCTURES TO NORTH AND SANDY BEACH TO WEST.

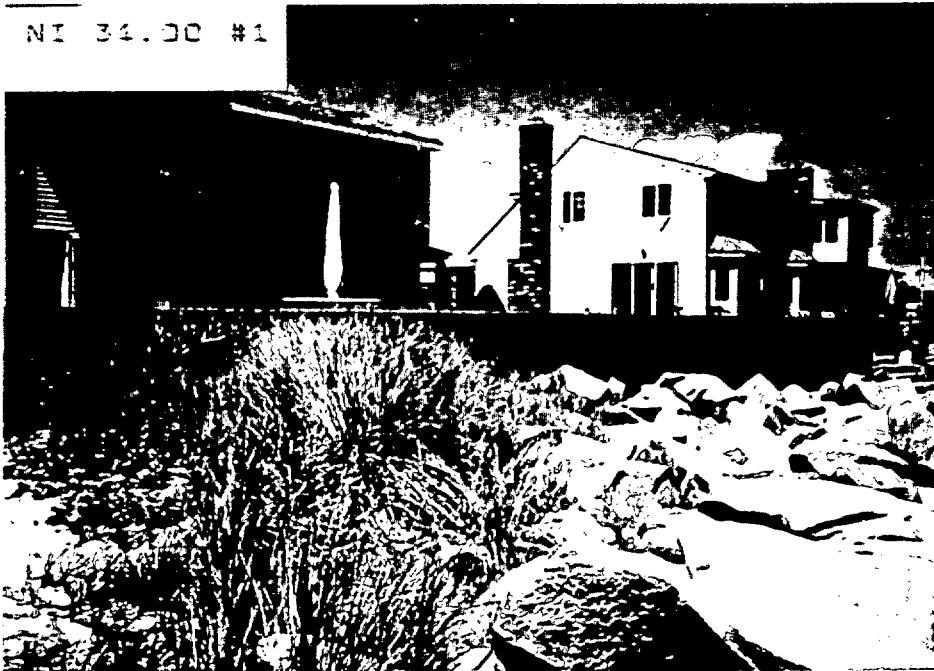
NI 34.00 #1

TYPE OF STRUCTURE: SEAWALL/RIPRAP CONDITION: FAIR
MAIN FUNCTION : PROTECTION OF LAND FROM POTENTIAL WAVE ACTION
MATERIAL : CONCRETE

SANDY BEACH ON EITHER SIDE

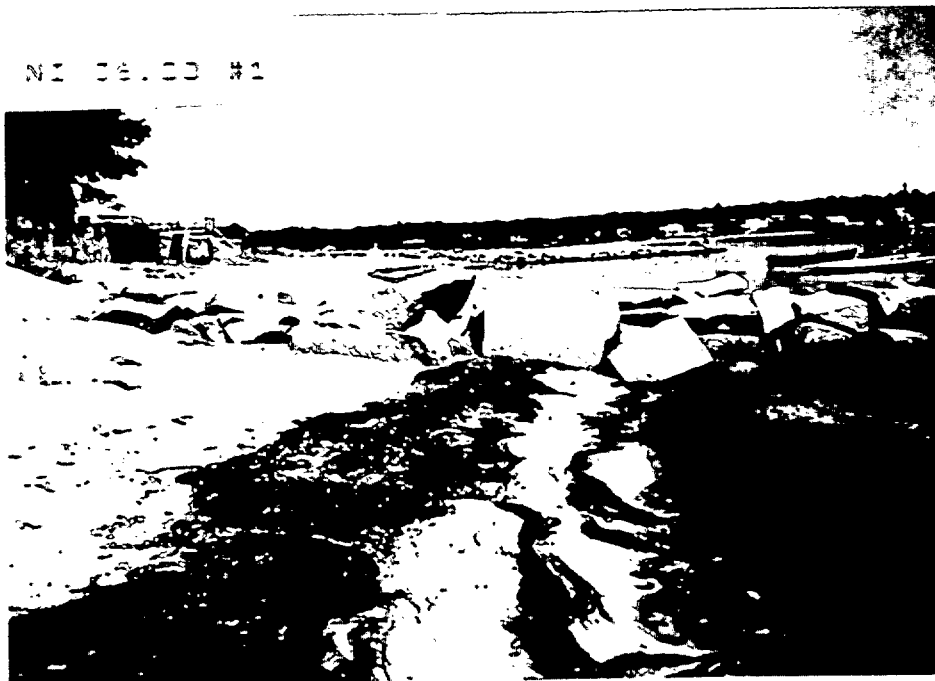
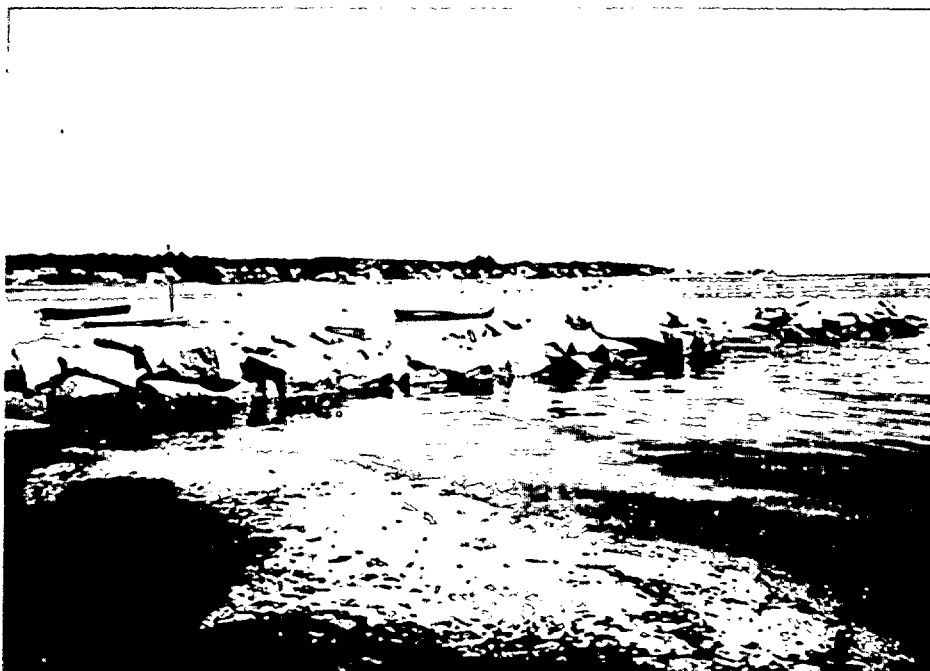
NI 06.00 #1

TYPE OF STRUCTURE: GROIN CONDITION: GOOD
MAIN FUNCTION : RETAINS BEACH TO EITHER SIDE
MATERIAL : STONE

SHORE IS SANDY BEACH TO EITHER SIDE

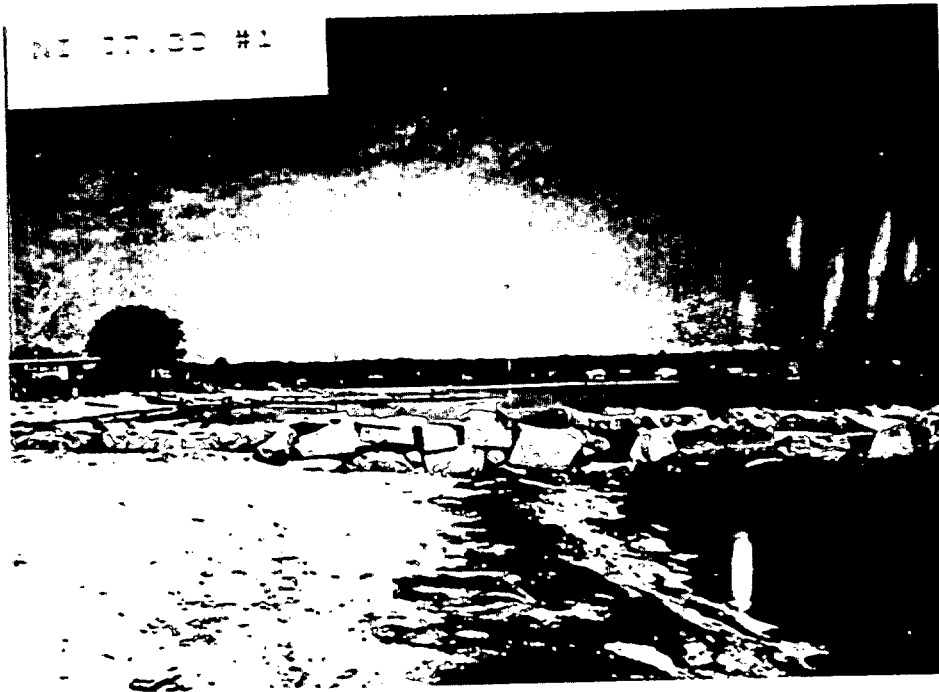
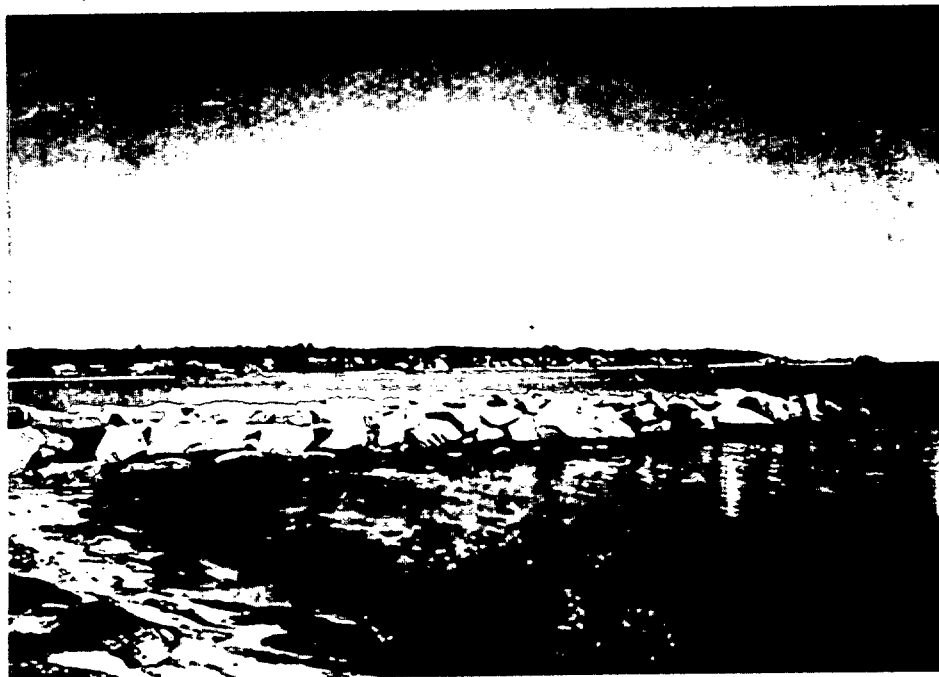
TYPE OF STRUCTURE: GROIN CONDITION: GOOD
MAIN FUNCTION : RETAINS BEACH TO EITHER SIDE
MATERIAL : STONE

SHORE IS SANDY BEACH TO EITHER SIDE

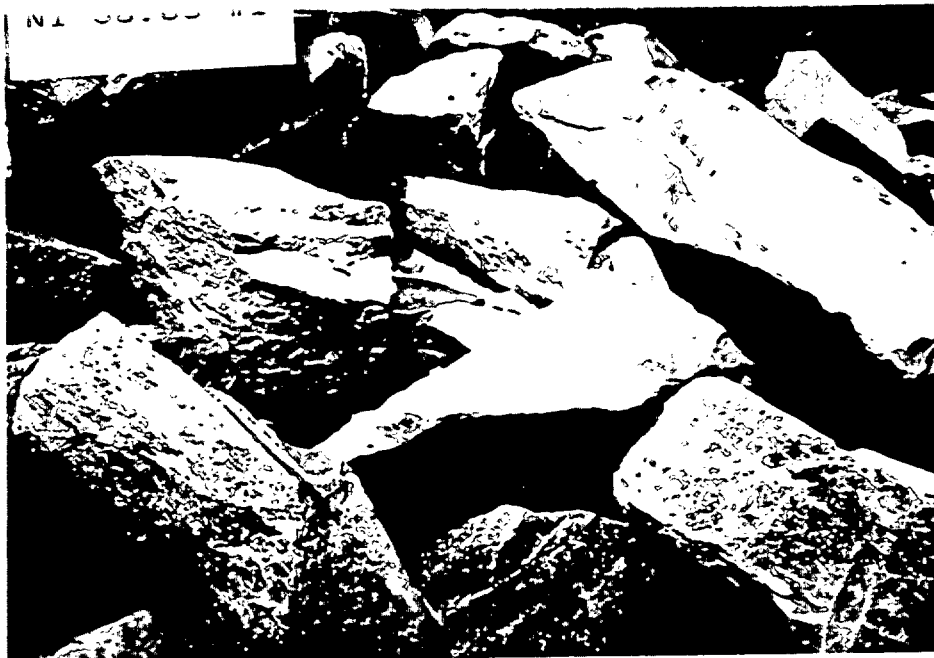
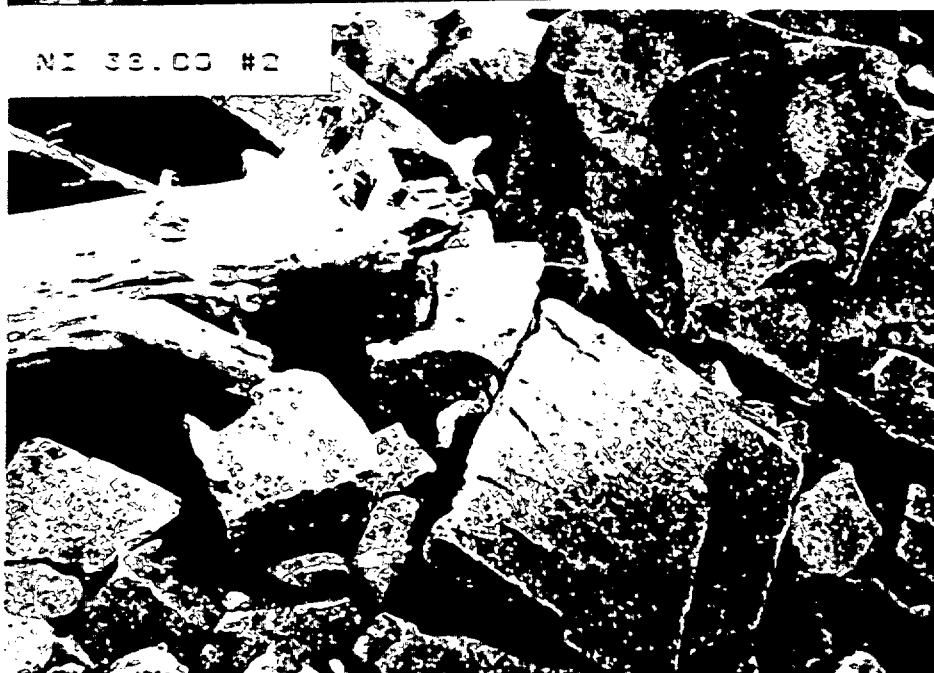
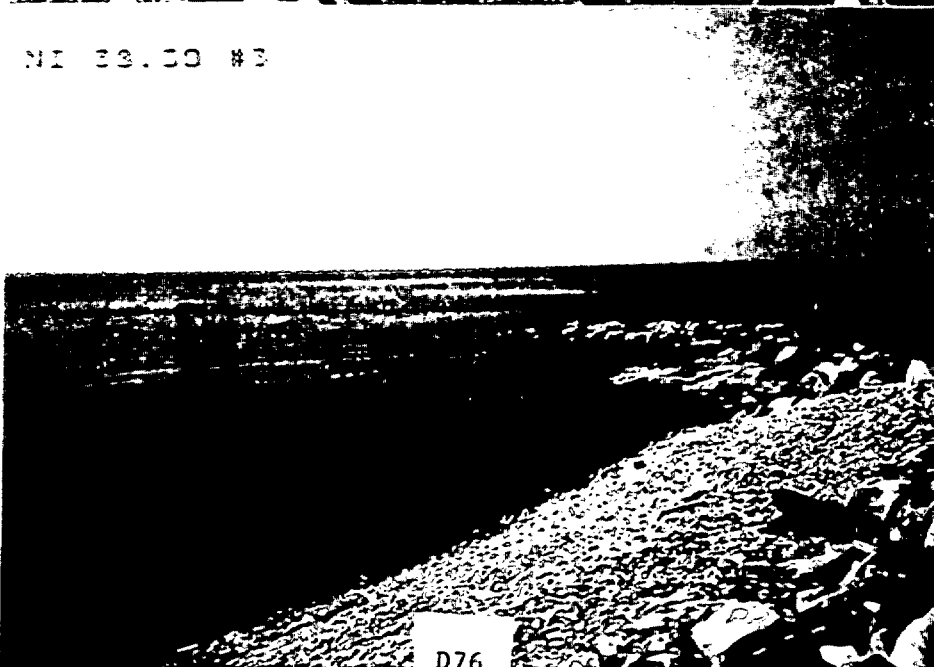
TYPE OF STRUCTURE: REVETMENT CONDITION: GOOD
MAIN FUNCTION : PREVENTS EROSION
MATERIAL : STONE

NORTHEAST UTILITIES NUCLEAR POWER PLANT. SHORE COMPLETELY
PROTECTED EITHER NATURALLY OR WITH QUARRY STONE.

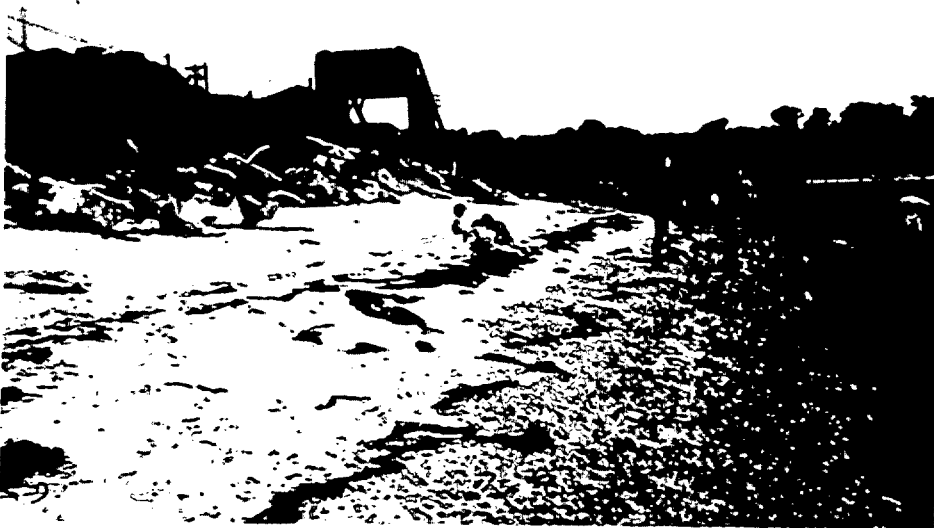
NI 39.00 #1

TYPE OF STRUCTURE: REVETMENT CONDITION:
MAIN FUNCTION : PROTECT SHORE FROM STORM ACTION
MATERIAL : STONE

SHORE:SANDY/PEBBLY BEACH

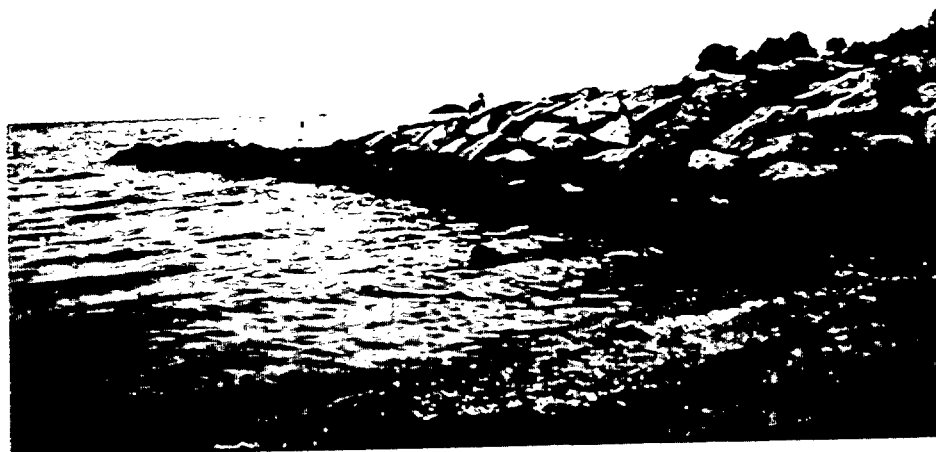
NI 40.00 #1

SANDY BEACH TO EITHER SIDE
